Manhole Inspection Summary

Manhole # S35II_031MH

Location Address: **336 FEDERAL ST**

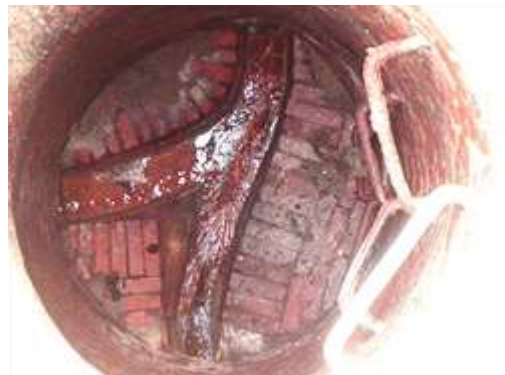
Top View

Corroded steps. Evidence of surcharge - Bench debris.

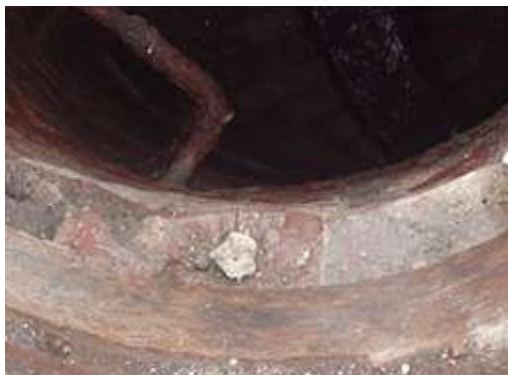
Defect

Frame leaks. Frame offset. Adjustment deterioration and infiltration.

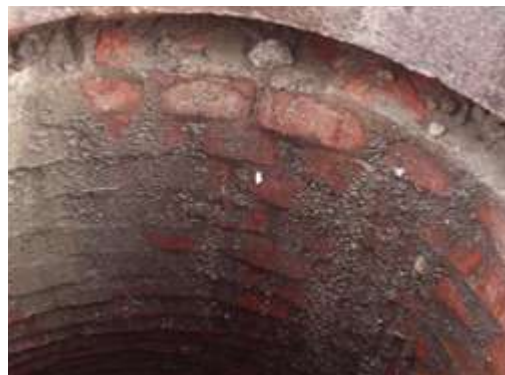
Defect

Frame leaks. Adjustment deterioration and infiltration.

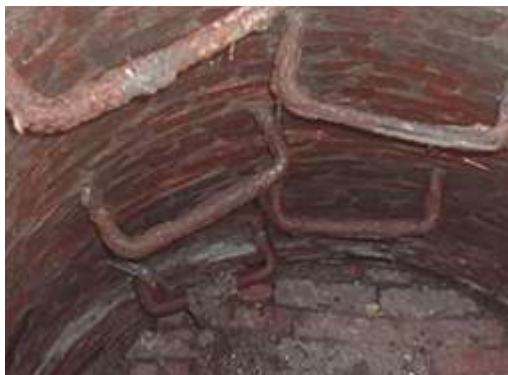
Defect

Barrel infiltration. Coroded steps

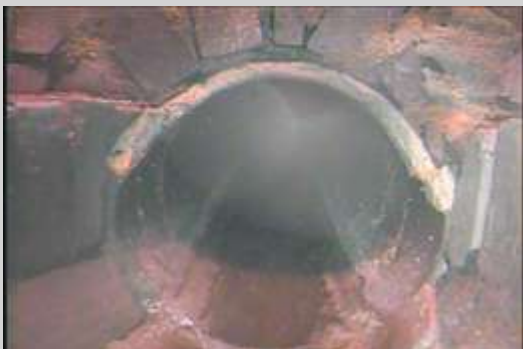
Pipe In @ 6 O'Clock

Deposits: ☐ None ☐ Mud ☐ Sludge ☐ Debris ☒ Grease

Silt Depth: **0** (in.) Deposits Extent: **Light**
